# Full scale test results of the RIMOB Crash Cushion

*Description of tests and results conform standard CEN/TC 226/WG1*

R-95-16  
Ing. C.C. Schoon & P. Broertjes  
Leidschendam, 1995  
SWOV Institute for Road Safety Research, The Netherlands

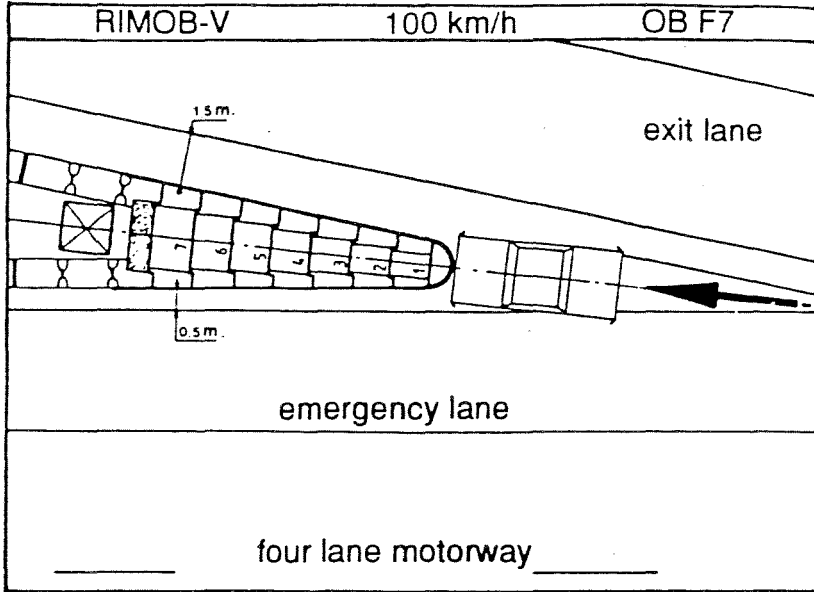
PRE TEST  
(test conditions  
projected on  
motorway situations)

Test impact speed: 100 km/h (0% difference)  
Test impact angle: 0° (0% difference)  
Test impact point: center

Opel Kadett Olympia 1500 Coupé	Opel Kadett B	Opel Kadett B
-----------------------------------	---------------	---------------

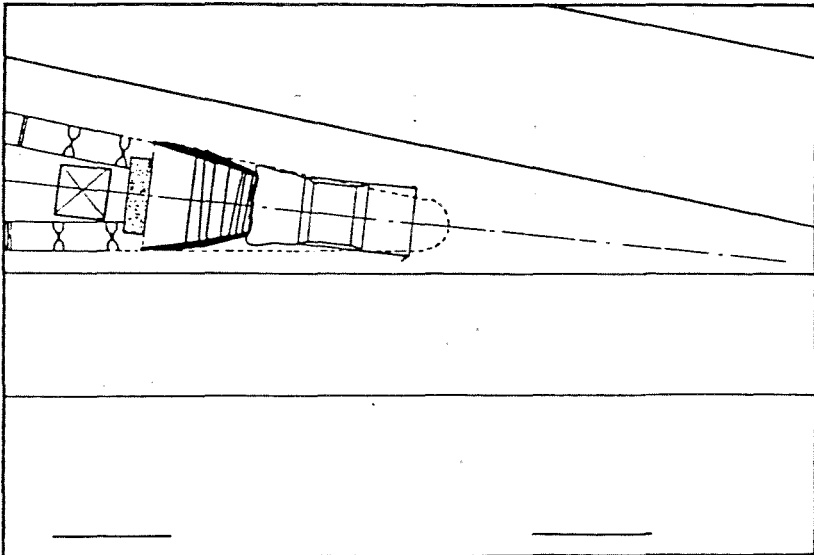
POST TEST  
SITUATION

- Test-number	F7	F11	F13
- Damage to RIMOB:	compression: 5.1 m dynamic compression: 5.35 m	compression: 4.5 m dynamic compression: 4.9 m	compression: 4.1 m dynamic compression: 4.9 m
- Maximum permanent deflection (lateral):	0.1 m	0 m	0 m
- Major parts fractured or detached?:	none	none	none

- Rebound:	0 m	0 m	0.7 m
- Length reduction of hood:	0.25 m	0.26 m	0.34 m
- Vehicle cockpit deformation index VCDI:	no deformation	no deformation	no deformation

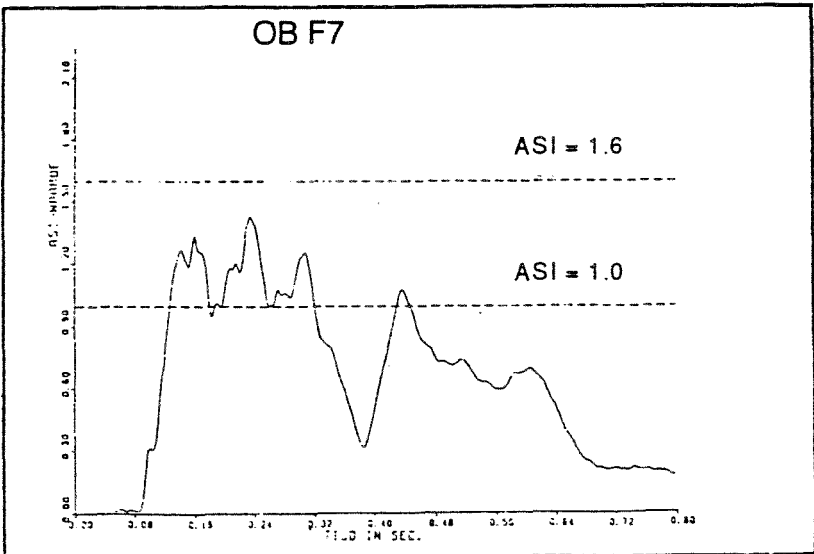
ASI-SWOV  
(values calculated  
for the time-history)

- Acceleration severity index ASI-CEN (criteria: $ASI_{max-belted} = 1,0$ )	0.87	no data *)	no data *)
- Acceleration severity index ASI-SWOV (zie graphs) (criteria: $ASI_{max-belted} = 1,6$ ; $ASI_{max-unbelted} = 1,0$ ;) )	1.5	no data *)	no data *)
- Average acceleration ( $a_{avg.} = v^2 / 2s$ ) ( $v =$ impact velocity; $s =$ dynamic compression distance):	72.1 m/s <sup>2</sup>	78.7 m/s <sup>2</sup>	78.7 m/s <sup>2</sup>

ASI-SWOV is based on  
limit acceleration:  
 $a_x = 7g$ ;  $a_y = 5g$ ;  $a_z = 6g$

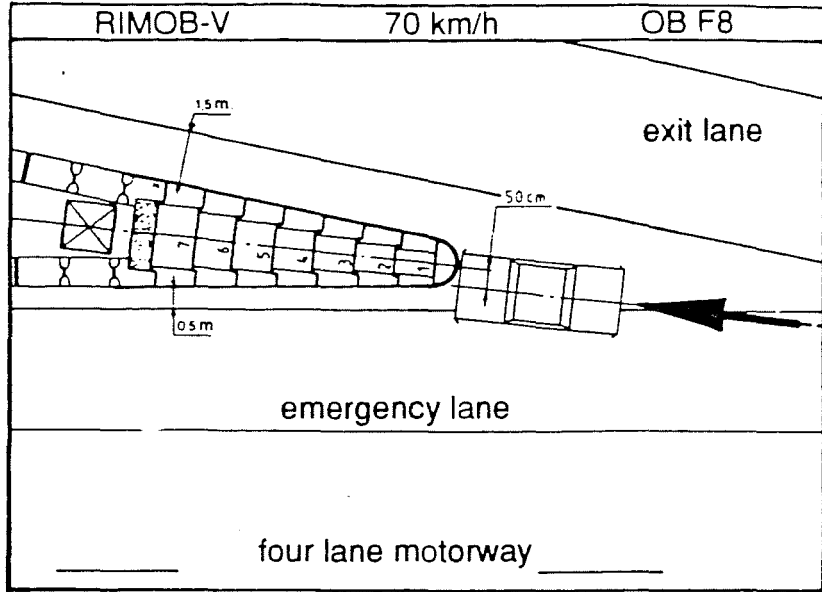
PRE TEST  
(test conditions  
projected on  
motorway situations)

Test impact speed: 70 km/h (12.5% difference)  
Test impact angle: 0° (0% difference)  
Test impact point: 0.5 m from the right side of the car's center

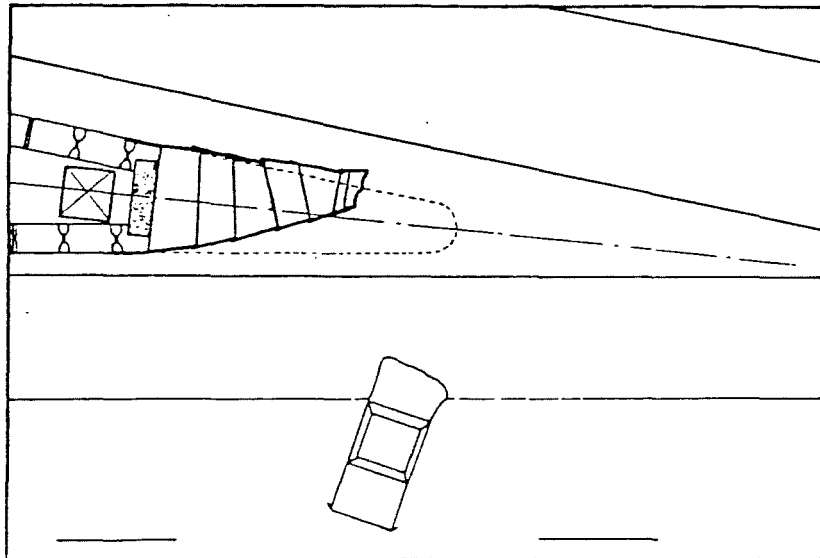
POST TEST  
SITUATION

compression: 2.4 m

0.33 m

0.34 m

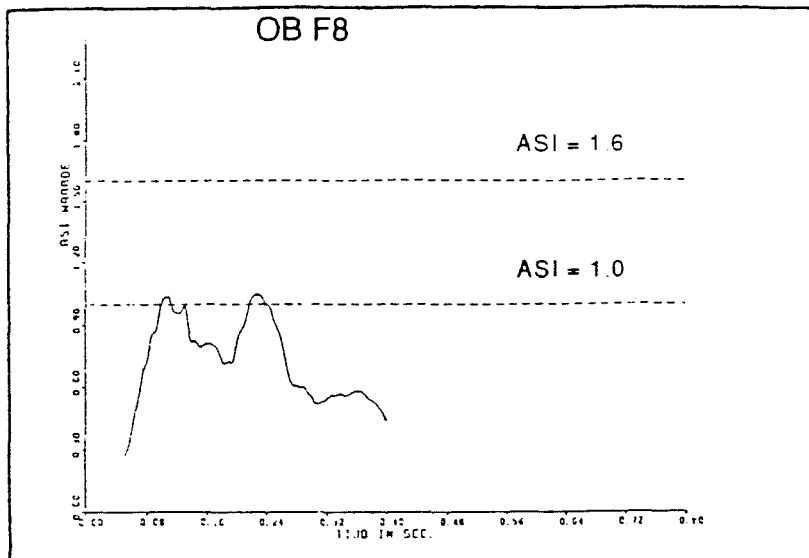
ASI-SWOV  
(values calculated  
for the time-history)

1.1

ASI-SWOV is based on  
limit acceleration:  
 $a_x = 7g$ ;  $a_y = 5g$ ;  $a_z = 6g$

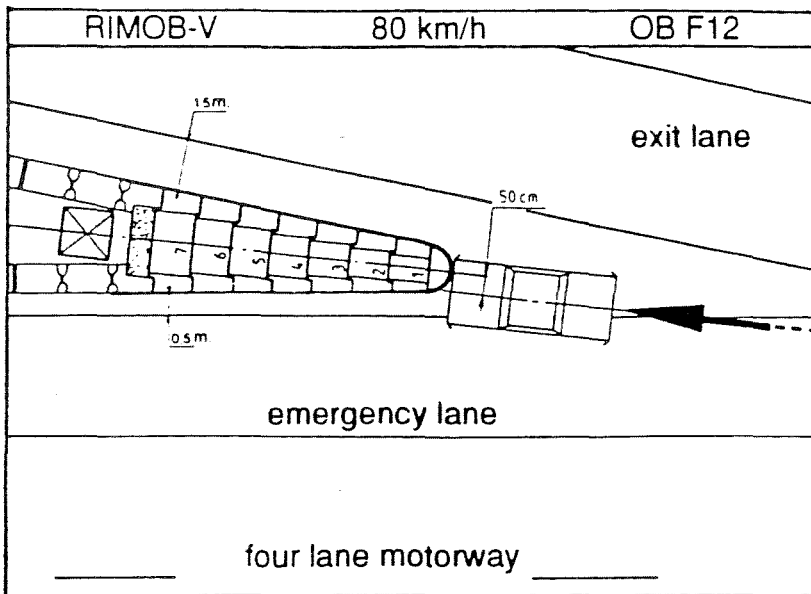
PRE TEST  
(test conditions  
projected on  
motorway situations)

Test impact speed: 80 km/h (0% difference)  
Test impact angle: 0° (0% difference)  
Test impact point: 0.5 m from the right side of the car's center

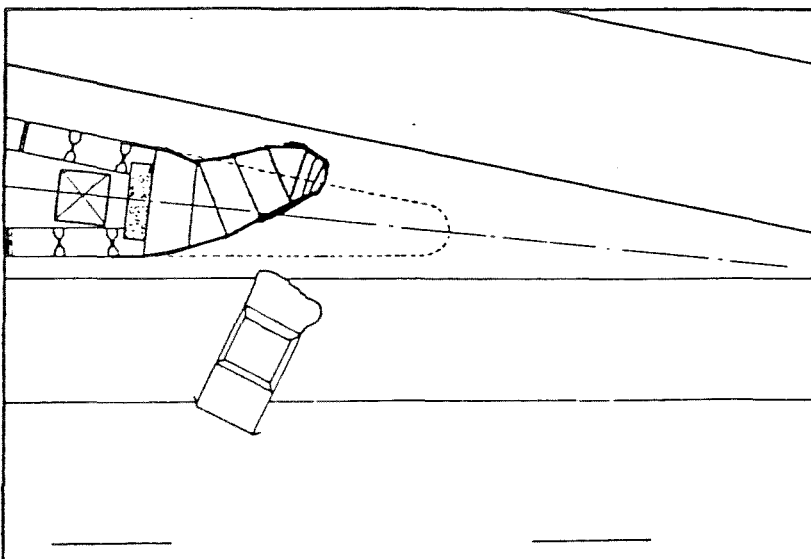
POST TEST  
SITUATION

compression: 3.3 m

0.95 m

0.37 m

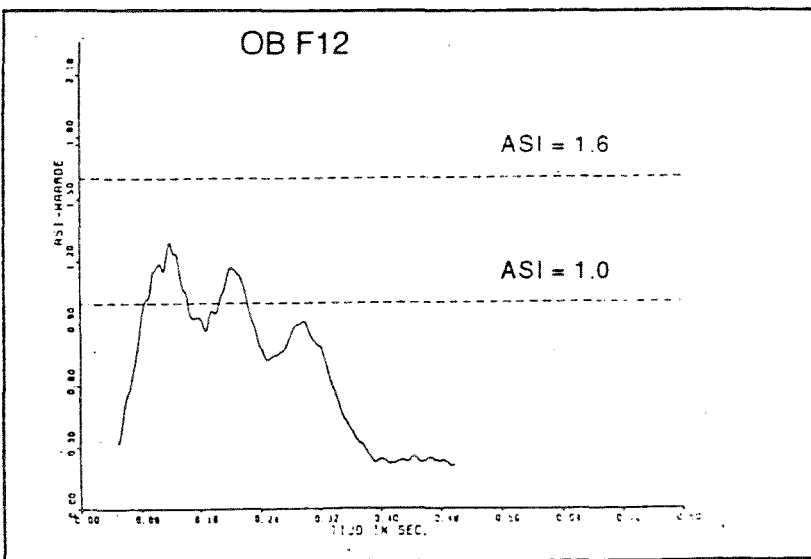
ASI-SWOV  
(values calculated  
for the time-history)

1.3

ASI-SWOV is based on  
limit acceleration:  
 $a_x = 7g$ ;  $a_y = 5g$ ;  $a_z = 6g$

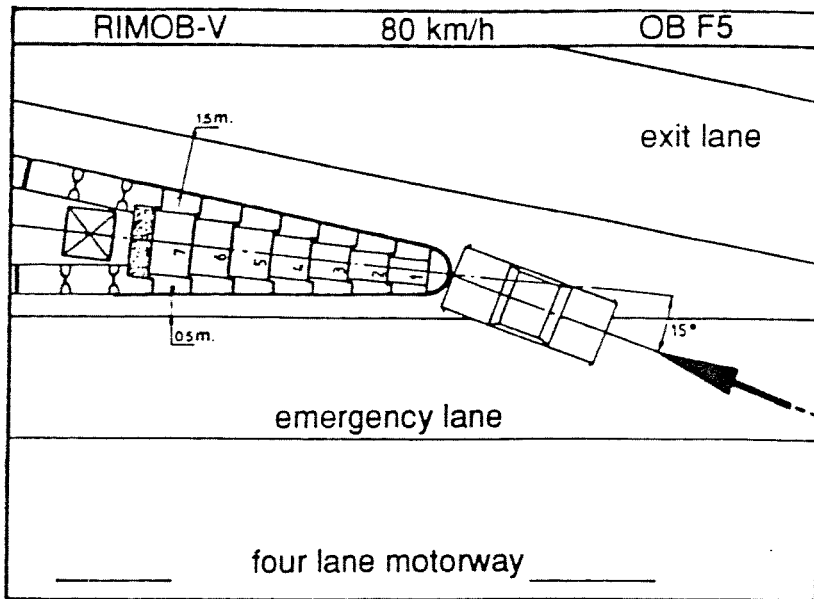
PRE TEST  
(test conditions  
projected on  
motorway situations)

One test is carried out: Test-number: F5  
Test impact speed: 80 km/h (0% difference)  
Test impact angle: 15.2° (1.3% difference)  
Test impact point: nose center

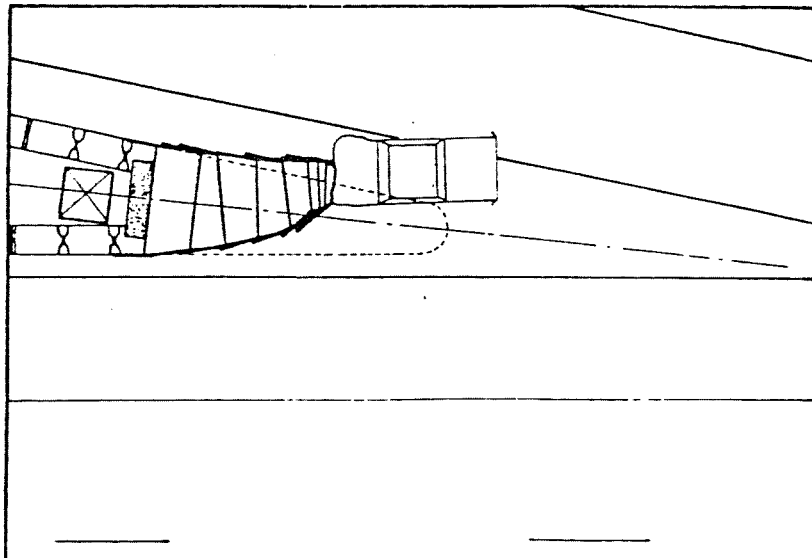
POST TEST  
SITUATION

compression: 3.2 m

0.81 m

0.30 m

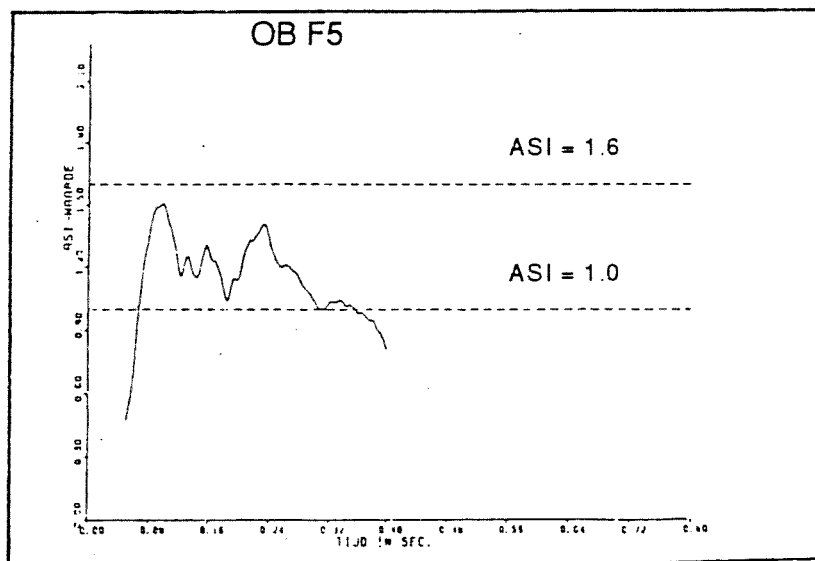
ASI-SWOV  
(values calculated  
for the time-history)

1.5

ASI-SWOV is based on  
limit acceleration:  
 $a_x = 7g$ ;  $a_y = 5g$ ;  $a_z = 6g$

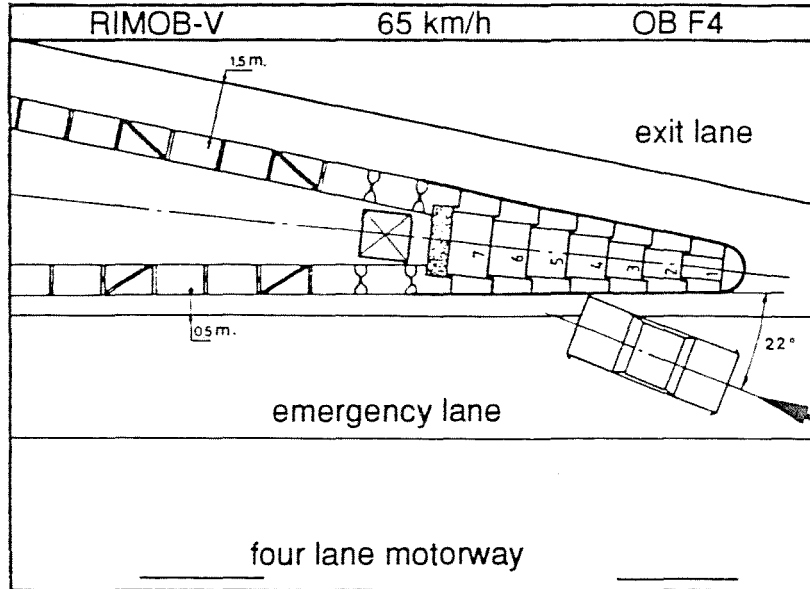
PRE TEST  
(test conditions  
projected on  
motorway situations)

One test is carried out: Test-number: F4  
Test impact speed: 65 km/h (30% difference)  
Test impact angle: 22.4° (49.3% difference)  
Test impact point: side (near front)

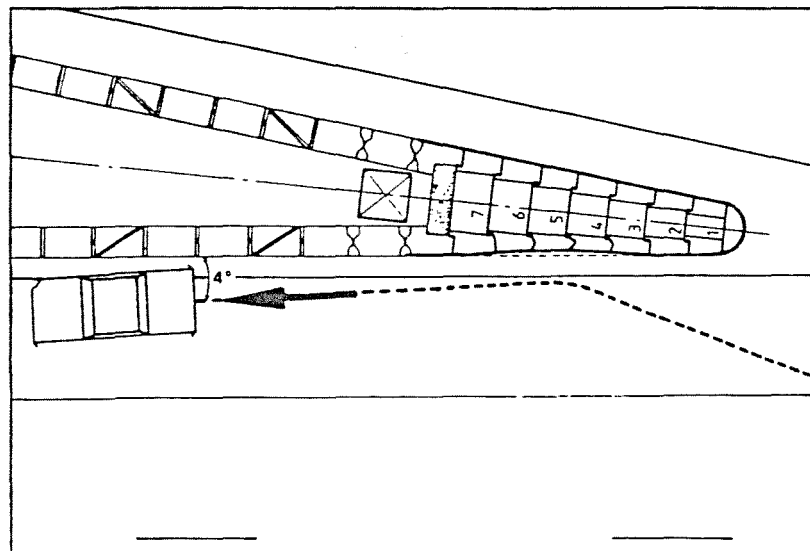
POST TEST  
SITUATION

One tube has been slightly deformed

0.10 m (departure side)

small dents and scratches

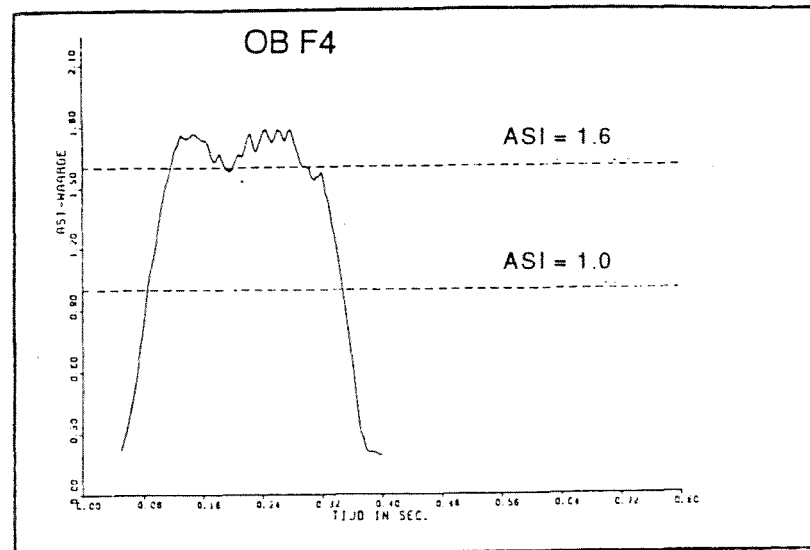
ASI-SWOV  
(values calculated  
for the time-history)

1.8 \*)

\*) ASI is not fully appropriate for side impact tests. See for instance the data of the head acceleration of the instrumented dummies at the side impact test F10. The values show a HIC-value which is far below the criteria of 1000.

ASI-SWOV is based on  
limit acceleration:  
 $a_x = 7g$ ;  $a_y = 5g$ ;  $a_z = 6g$

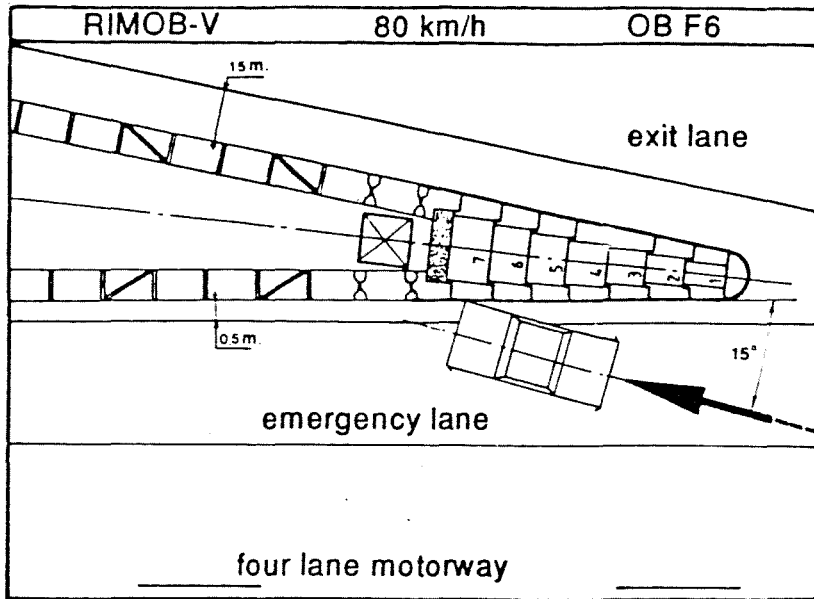
PRE TEST  
(test conditions  
projected on  
motorway situations)

Test impact speed: 80 km/h (0% difference)  
Test impact angle: 15° (0% difference)  
Test impact point: side (near back)

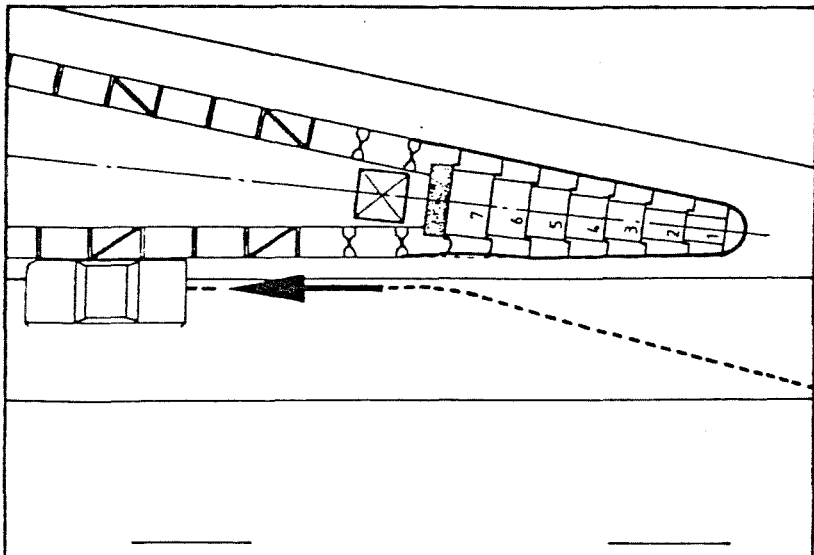
POST TEST  
SITUATION

slight

0 m (departure side)

small dents and scratches

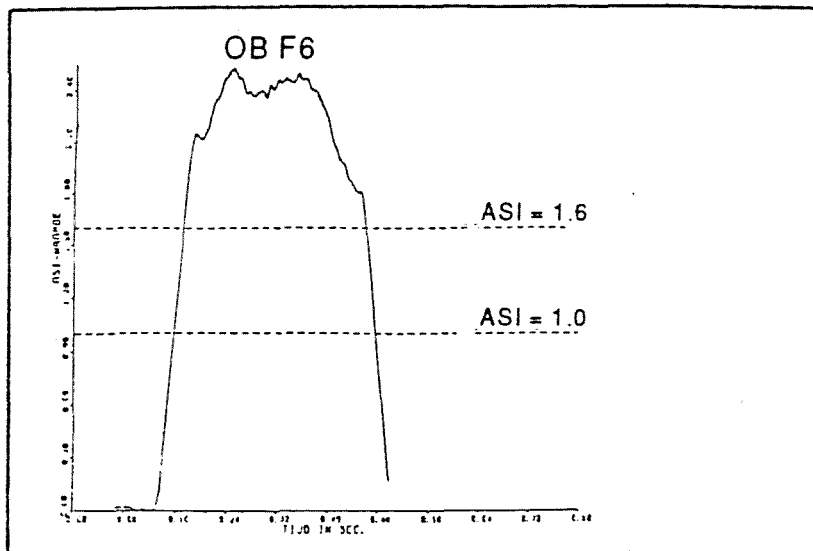
ASI-SWOV  
(values calculated  
for the time-history)

2.5 \*)

\*) ASI is not fully appropriate for side impact tests. See the results of the instrumented dummy at test F10. The values of the ASI are rather high, while the values of the head acceleration and belt load are low.

ASI-SWOV is based on  
limit acceleration:  
 $a_x = 7g$ ;  $a_y = 5g$ ;  $a_z = 6g$

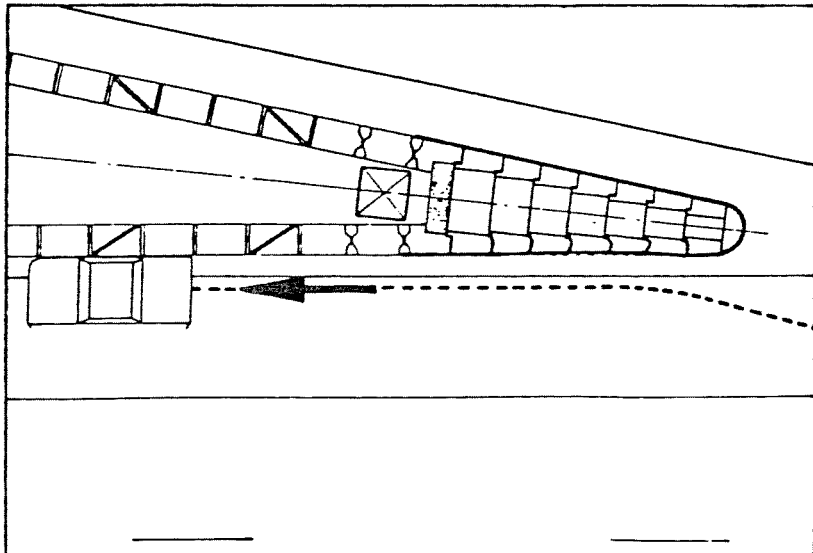
POST TEST  
SITUATION

slight

0.25 m (departure side)

small dents and scratches

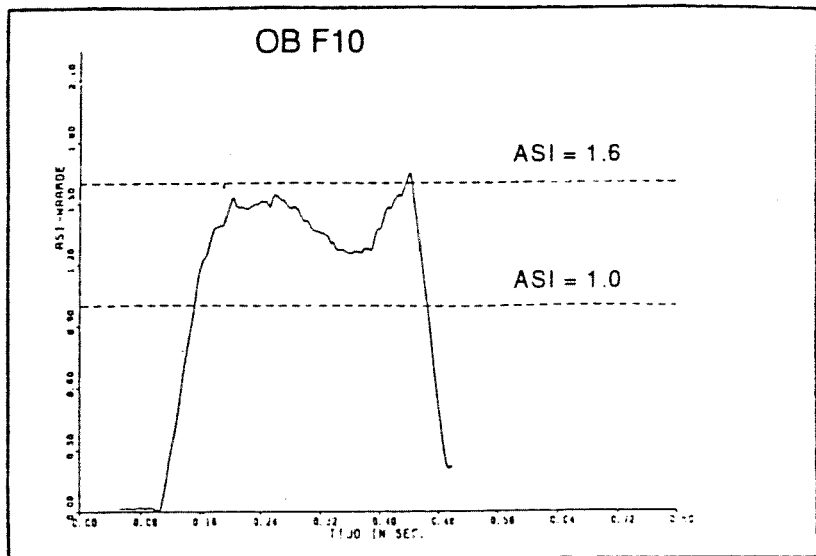
ASI-SWOV  
(values calculated  
for the time-history)

1.6 \*)

ASI-SWOV is based on  
limit acceleration:  
 $a_x = 7g$ ;  $a_y = 5g$ ;  $a_z = 6g$

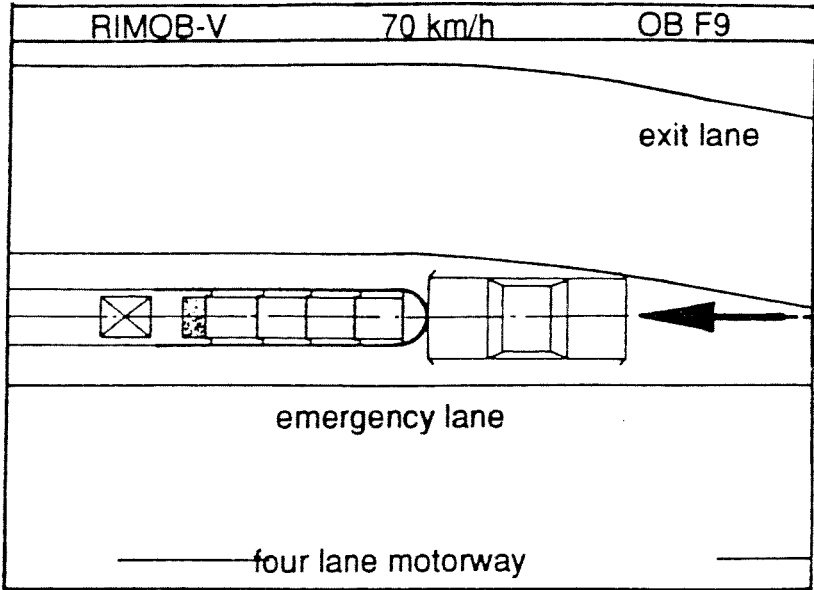
PRE TEST  
(test conditions  
projected on  
motorway situations)

Test impact speed: 70 km/h (12.5% difference)

Test impact angle: 0° (0% difference)

Test impact point: center

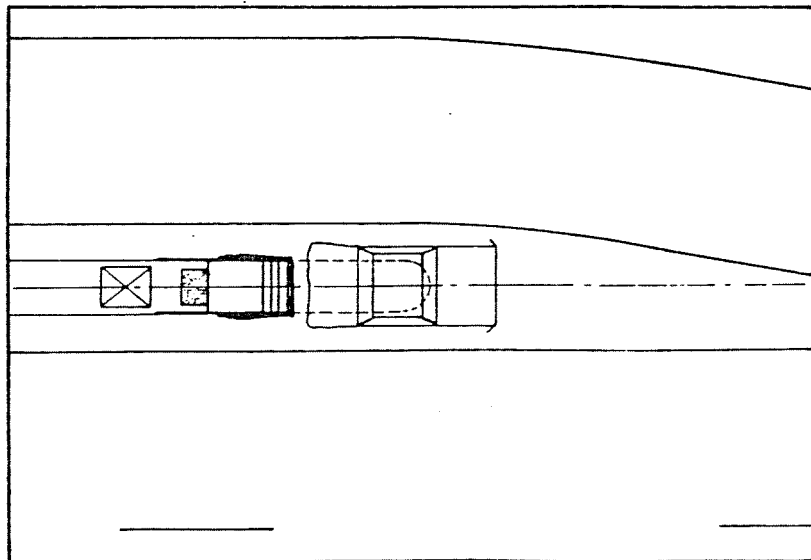
POST TEST  
SITUATION

compression: 2.9 m  
dynamic compression: 2,9 m

0.26 m

0.21 m

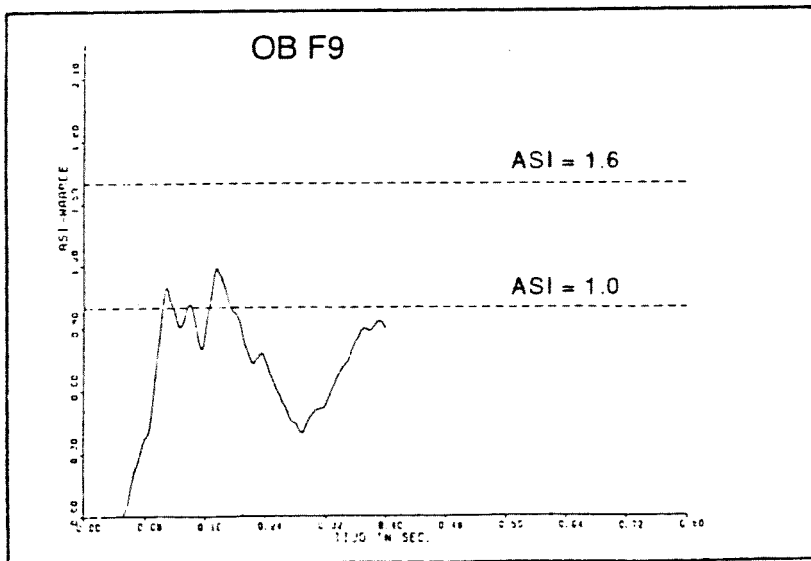
ASI-SWOV  
(values calculated  
for the time-history)

1.2

ASI-SWOV is based on  
limit acceleration:  
 $a_x = 7g$ ;  $a_y = 5g$ ;  $a_z = 6g$

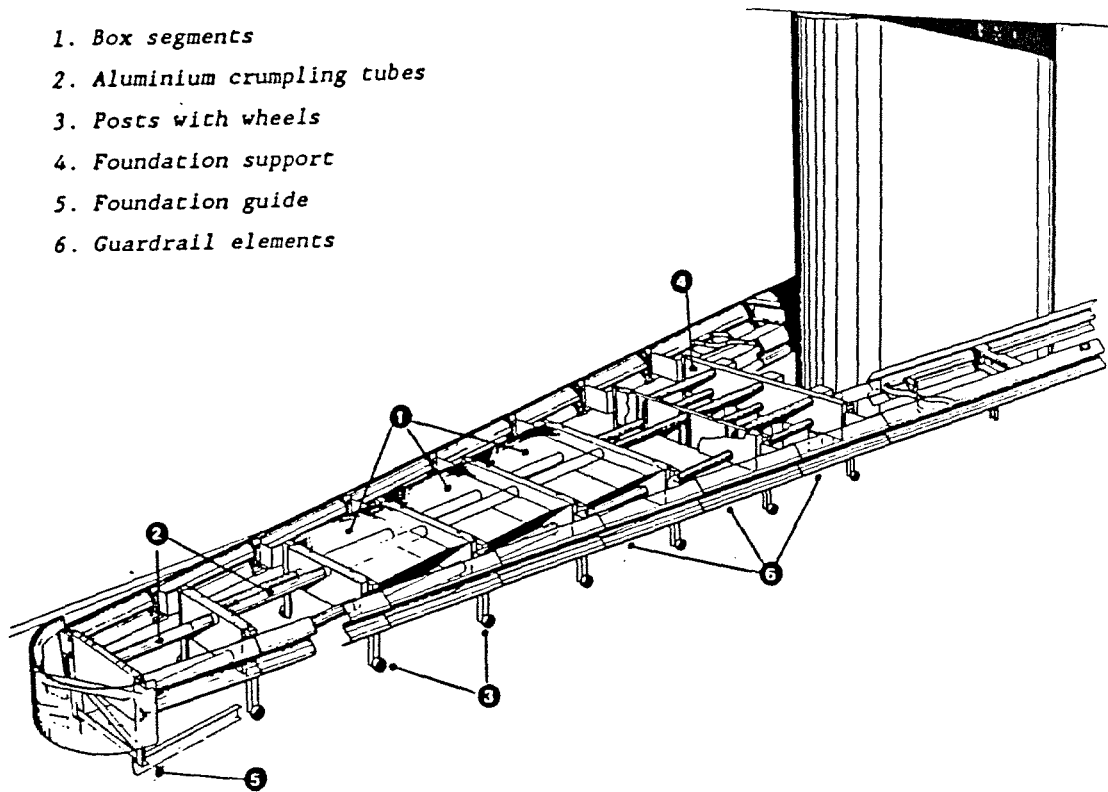
Open-worked drawing of RIMOB

1. Box segments
2. Aluminium crumpling tubes
3. Posts with wheels
4. Foundation support
5. Foundation guide
6. Guardrail elements

A RIMOB (see Annex 1) consists of a composition of box-like segments which are compressed in a head-on collision. Each segment is one metre long and contains aluminium tubes which are placed in axial direction. The tubes serve to be compressed in a violent head-on collision to a maximum of approximately 20% of their initial length. The RIMOB also has side protection that consists of 2 m long guide-rail-elements which are partly placed on top of each other. Because of this placement the parts can slip on top of each other when this is needed. A standard profile is used. In case of a collision with the side of a RIMOB, it functions like a regular barrier construction.

The impact which RIMOB can absorb can be programmed. The absorption can be adjusted by changing the number of segments, the number of crumpling tubes per segment, the diameter of the tubes and the thickness of the tube-walls. The RIMOB is attached to the ground at only two points. The advantages are simple foundation and easy erection. Standard barriers can be connected to RIMOB, so it can be fully integrated.

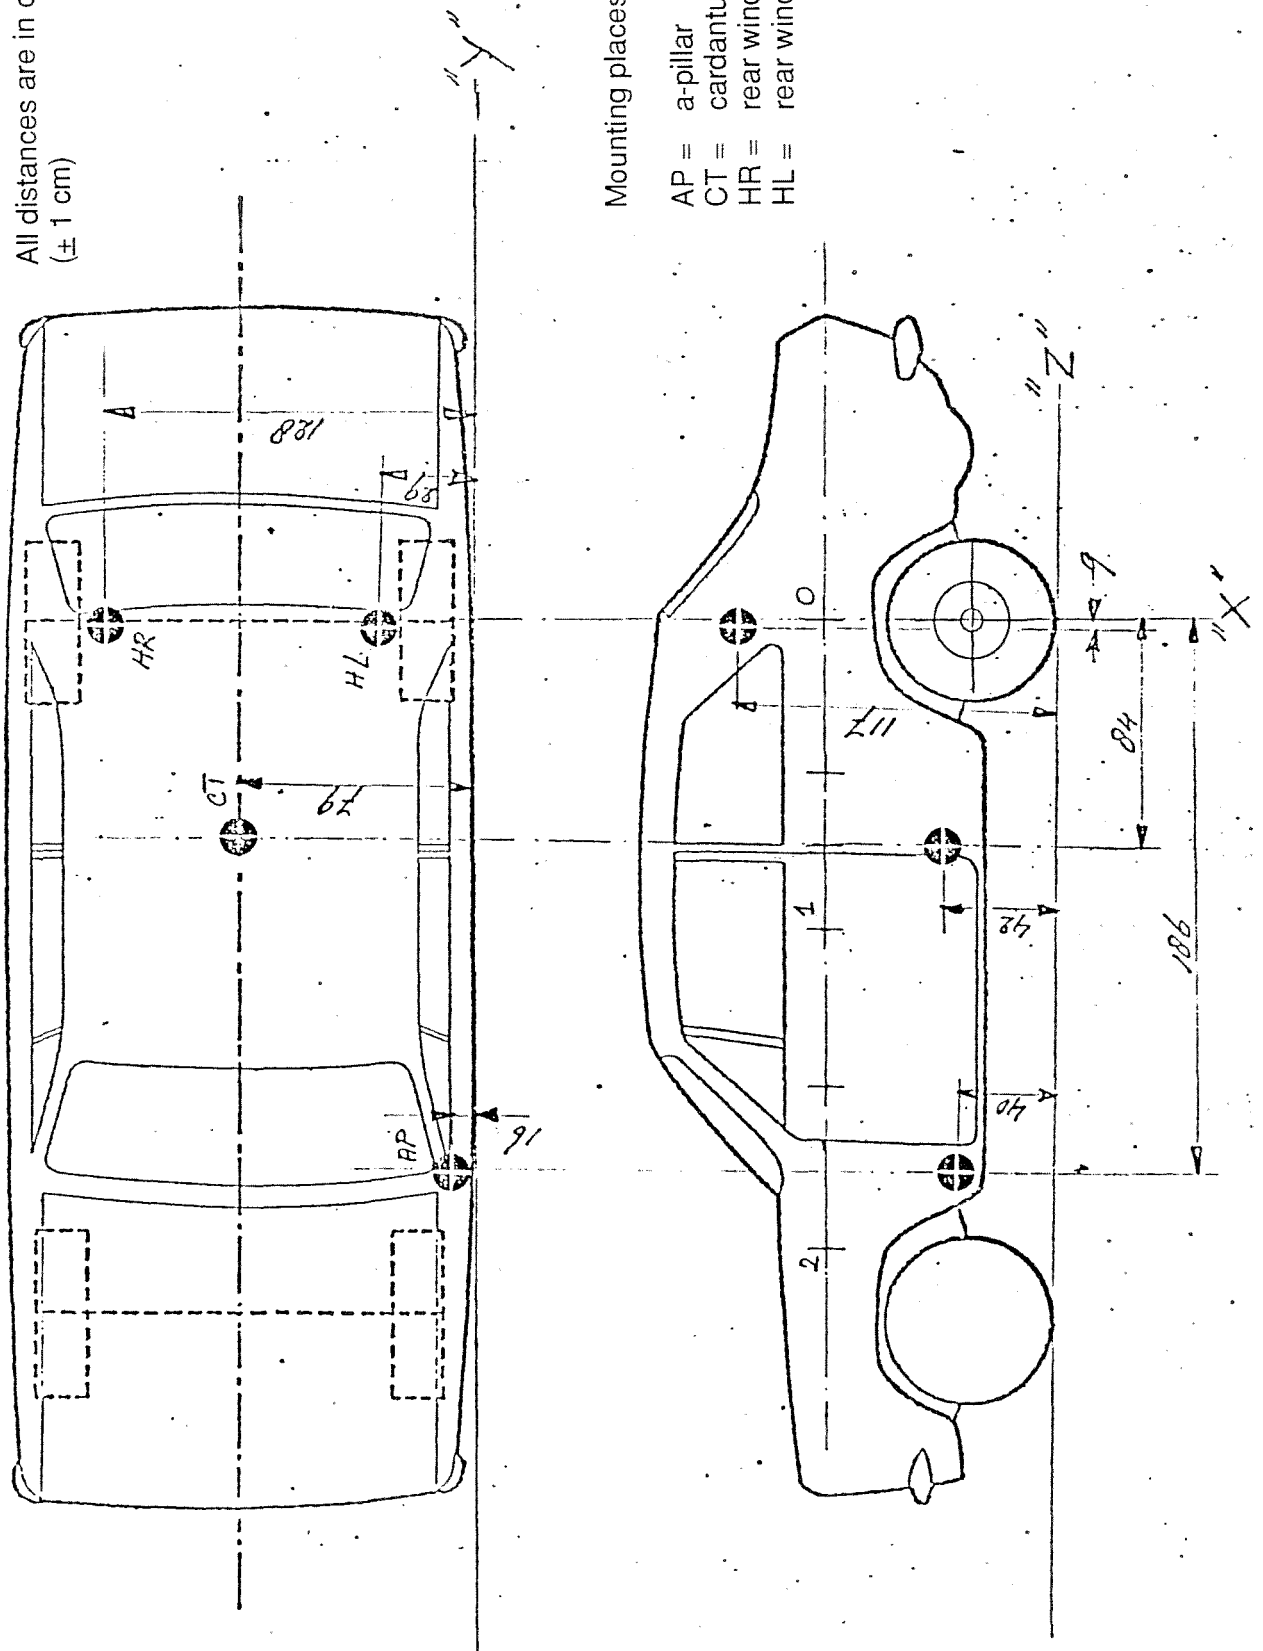
All distances are in cm  
(± 1 cm)

Mounting places:

- AP = a-pillar
- CT = cardantunnel
- HR = rear window right
- HL = rear window left

The test vehicles were provided with triaxial acceleration meters, excluded the tests F11 and F13 (see the remark at these tests). For the positions of the acceleration meters see Annex 4.
